SXP Recall Information

Winchester SXP (3 1/2" Chamber) Shotgun Safety Warning and Recall Notice.

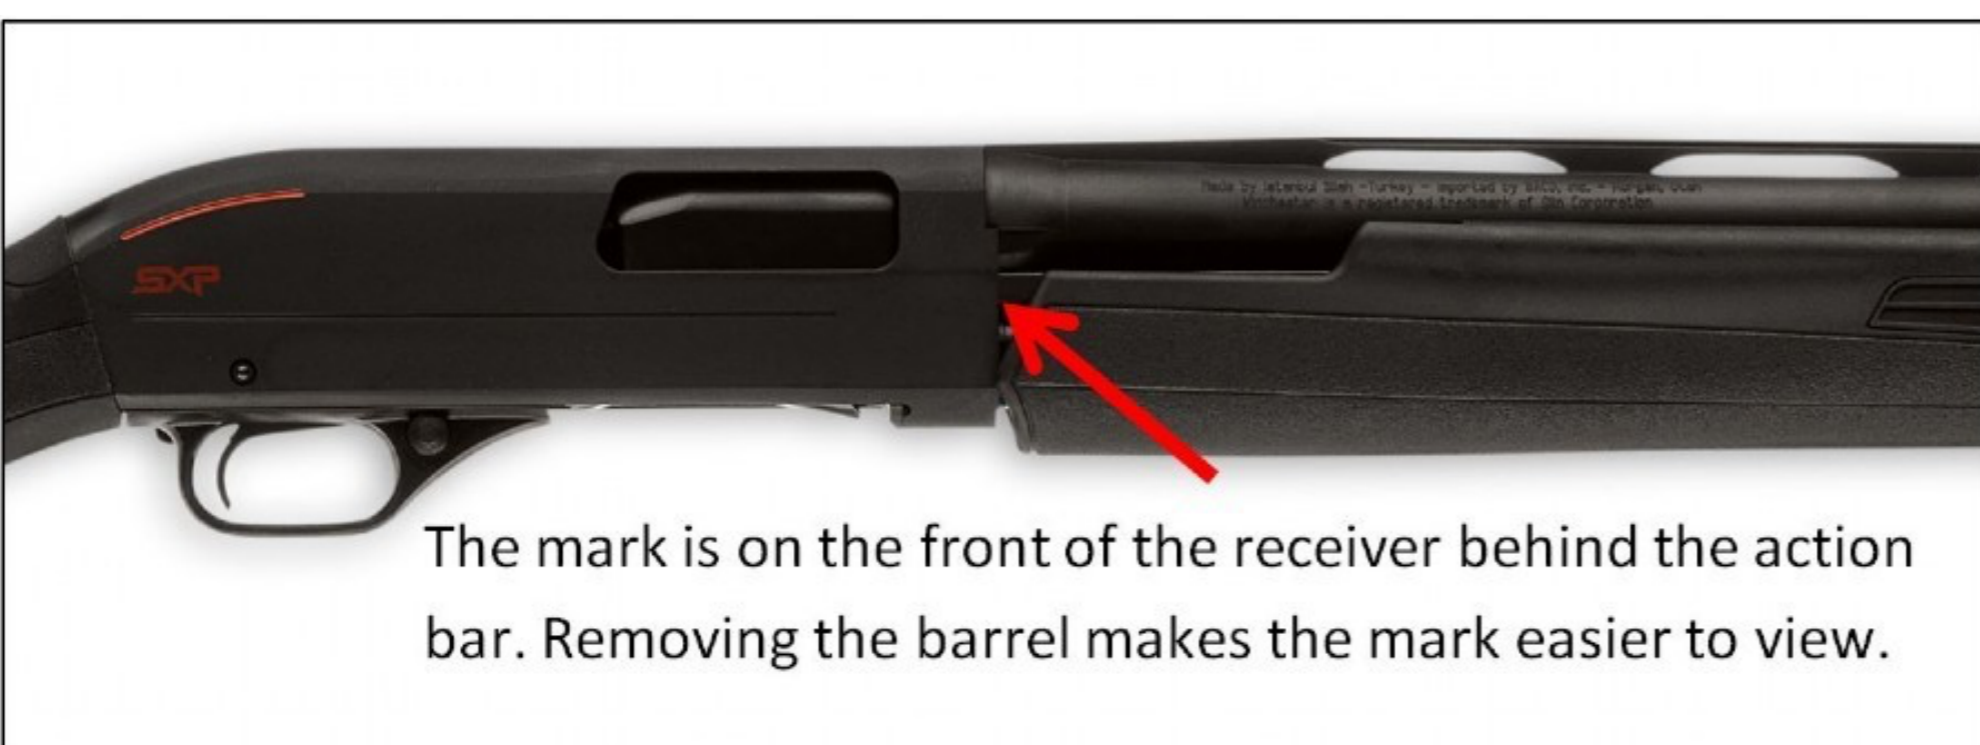
The mark is on the front of the receiver behind the action bar. Removing the barrel makes the mark easier to view.

Upon inspection and/or repair by the Winchester Repeating Arms Service Center, all SXPs affected by this recall will be inconspicuously marked on the front of the receiver as shown below in the illustration. If an SXP already has this marking, the firearm has been inspected and/or repaired.

To view the mark use a flashlight or other light source to peer past the action bars to the front of the receiver. To view the mark more easily, you can remove the barrel. Remember to . . .

1. After assuring your shotgun is unloaded, unscrew the magazine cap.
2. Pull the barrel forward and off the magazine tube, away from the receiver.
3. Look for the indented dot on the front to the receiver, on the left side.
4. When the inspection is complete, return the barrel to its original position and tighten the magazine cap.

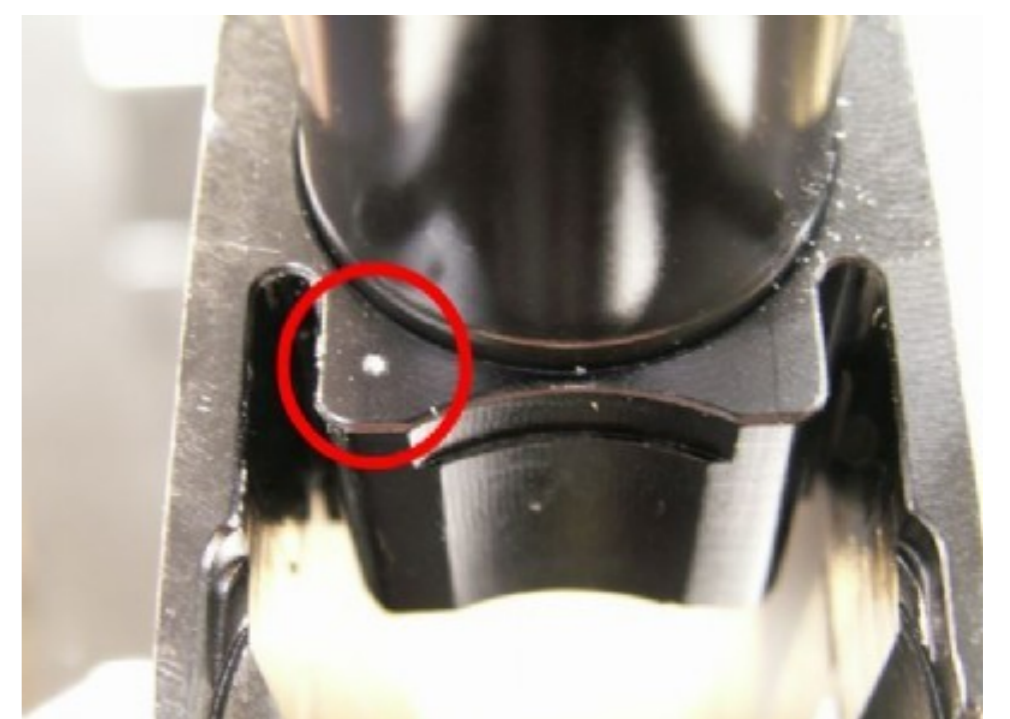
Shown is the indented dot indicator. This photo is shown with the action bars removed for clarity.
